Roofing for Historic Buildings

Sarah M. Sweetser

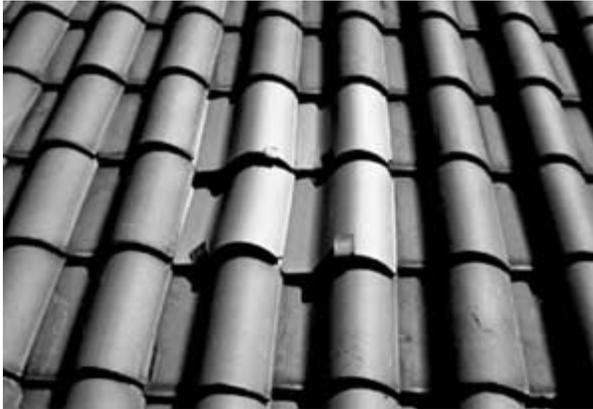
Repairs on this pantile roof were made with new tiles held in place with metal hangers. Photo: NPS files.

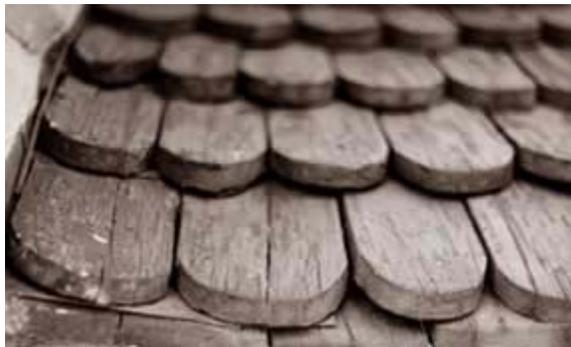
Replacement of particular historic details is important to the individual historic character of a roof, such as this rounded butt wood shingle roof. In the restoration, the drainage around a dormer was improved by the addition of carefully concealed modern metal flashing. Photo: NPS files.

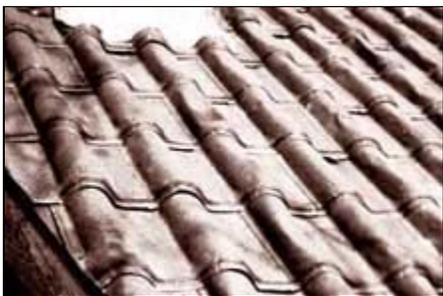
Galvanized sheet-metal shingles imitating the appearance of pantiles remained popular from the second half of the 19th century into the 20th century. Photo: NPS files.

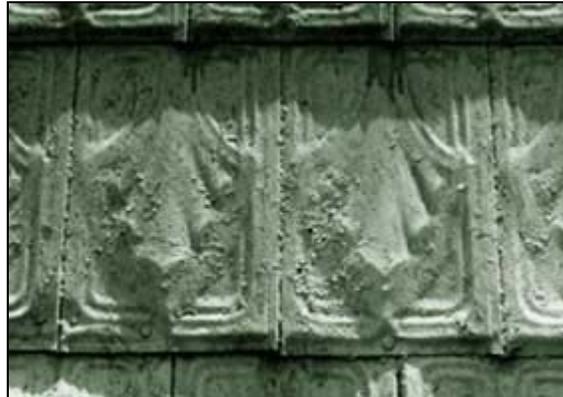
Tin shingles, commonly embossed to imitate wood or tile, or with a decorative design, were popular as an inexpensive, textured roofing material. Photo: NPS files.

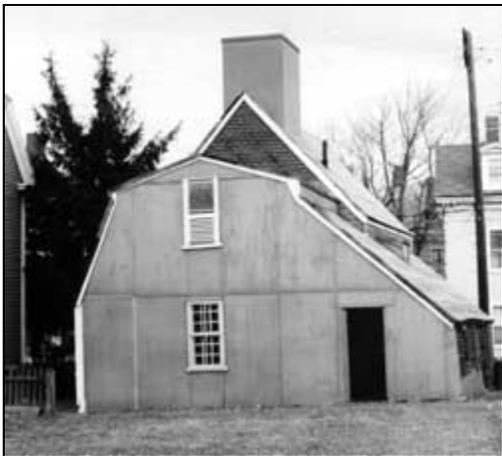
Temporary stabilization or "mothballing" with materials, such as plywood and building paper, can protect the roof of a project until it can be properly repaired or replaced. Photo: NPS files.

It may be necessary to carry out an immediate and temporary stabilization to prevent further deterioration until research can determine how the roof should be restored or rehabilitated, or until funding can be provided to do a proper job. A simple covering of exterior plywood or roll roofing might provide adequate protection, but any temporary covering should be applied with caution. One should be careful not to overload the roof structure, or to damage or destroy historic evidence or fabric that might be incorporated into a new roof at a later date. In this sense, repairs with caulking or bituminous patching compounds should be recognized as potentially harmful, since they are difficult to remove, and at their best, are very temporary.

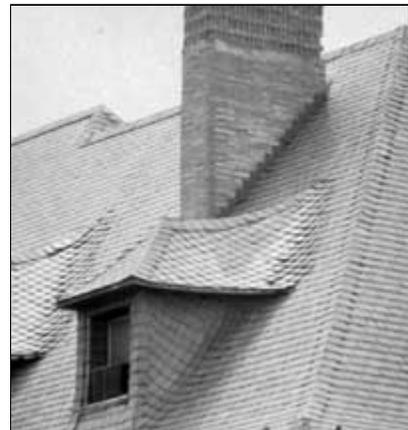
Because of the roof's visibility, the slate detailing around the dormers is important to the character of this structure. Photo: NPS files.

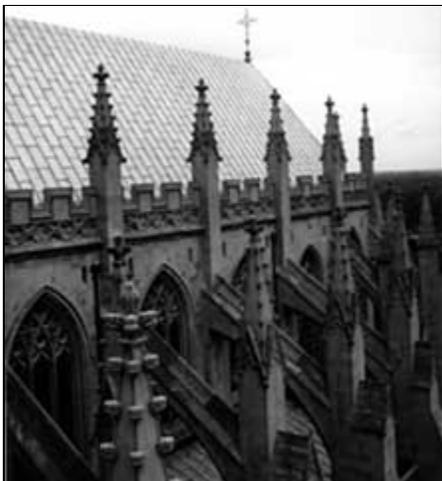
Good design and quality materials for the roof surface, fastenings, and flashing minimize

failures. Photo: NPS files.

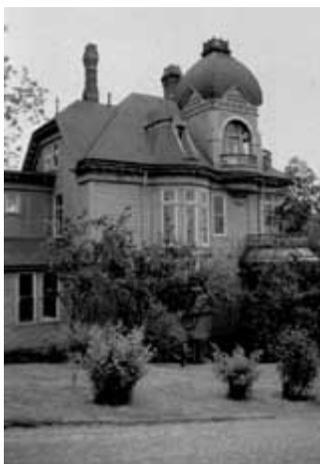
Special problems inherent in the design of an elaborate historic roof can be controlled through regular maintenance. The shape and detailing are essential elements of the building's historic character, and should not be modified, despite the use of alternative surface materials. Photo: NPS files.
