The Maintenance and Repair of Architectural Cast Iron

John G. Waite, AIA
Historical Overview by Margot Gayle

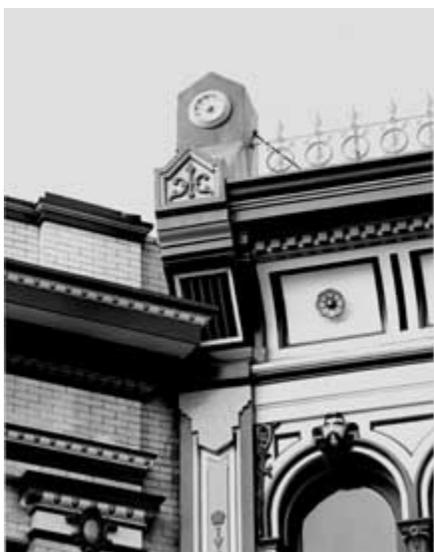
This shows a detail of a polychromed cast-iron facade in Petaluma, California, 1886 (O'Connell and Lewis, Architectural Iron Works, San Francisco). Photo: Don Meacham.

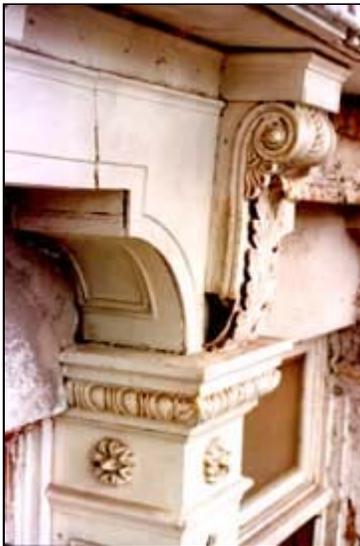
Structural crack, gaps at joints between components, and a large opening where part of the console bracket is missing are the problems evident in this cast-iron assembly. Photo: Ford, Powell & Carson.

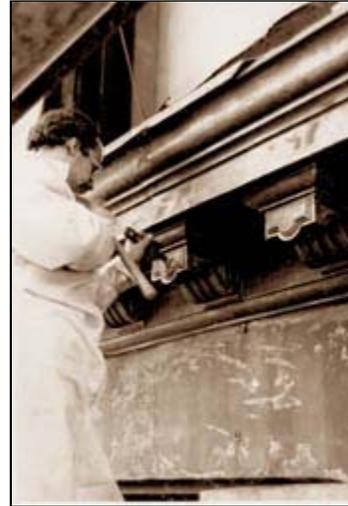
Where chemical paint stripping is involved, careful planning of the sequence of work and inspection by an architect or conservator to ensure strict compliance with the contract documents is important to minimize the risk of problems. Photo: Raymond M. Pepi, Building Conservation Associates.

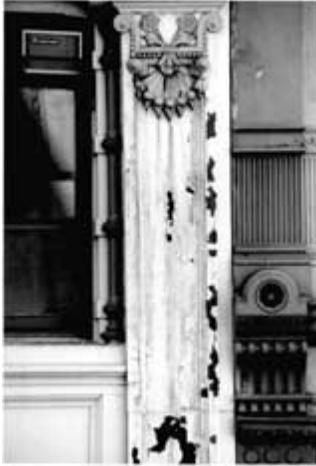
On this building, a strong alkaline paint remover was used, and apparently was not adequately rinsed or neutralized. Over a period of months, the newly applied paint began to peel and streaks of rust appeared on the iron. Photo: Kim Lovejoy.

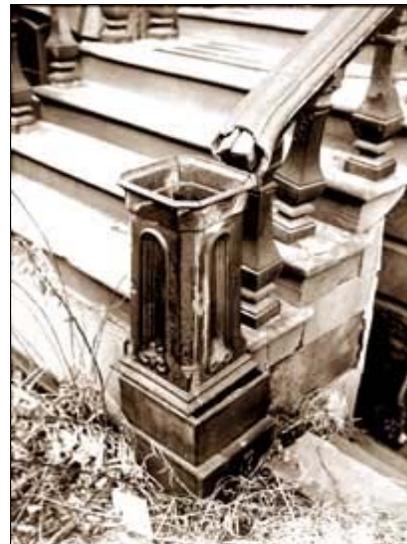
In an effort to repair the stair railing, concrete was poured around the wood spacer inside the railing ceiling. Water penetrated the railing and reacted with the concrete to accelerate the corrosion of the iron. Photo: John G. Waite.

The internal voids of balusters, newel posts, statuary, and other elements should not be filled with concrete; it is an inappropriate treatment that causes further problems. As the concrete cures, it shrinks, leaving a space between the concrete and cast iron. Water penetrating this space does not evaporate quickly, thus promoting further rusting. The corrosion of the iron is further accelerated by the alkaline nature of concrete. Where cast-iron elements have been previously filled with concrete, they need to be taken apart, the concrete and rust removed, and the interior surfaces primed and painted before the elements are reassembled.

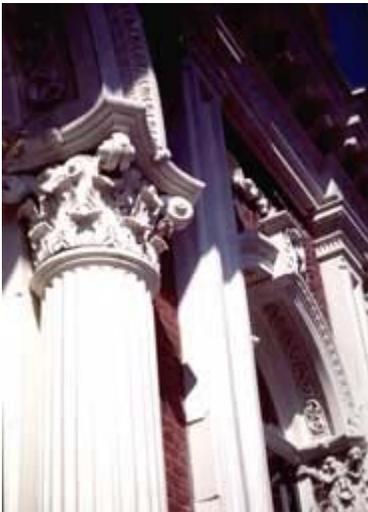
Fiberglass columns and aluminum capitals were installed to replicate the ornamental features on the east facade of the New Market Theater in Portland, Oregon. Photo: William J. Hawkins, III.

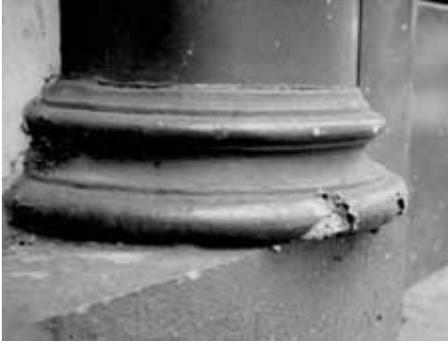
This lightweight fiberglass column at street level sustained damage from impact within a few years of installation. Photo: Building Conservation Associates.

Reinforced polyester, commonly known as fiberglass, is often used as a lightweight substitute for historic materials, including cast iron, wood, and stone. In its most common form, fiberglass is a thin, rigid, laminate shell formed by pouring a polyester resin into a mold and then adding fiberglass for reinforcement. Like epoxies, fiberglass is non-corrosive, but is susceptible to ultraviolet degradation. Because of its rather flimsy nature, it cannot be used as a substitute for structural elements, cannot be assembled like cast iron and usually requires a separate anchorage system. It is unsuitable for locations where it is susceptible to damage by impact, and is also flammable.
