The Preservation and Repair of Historic Stained and Leaded Glass

Neal A. Vogel and Rolf Achilles

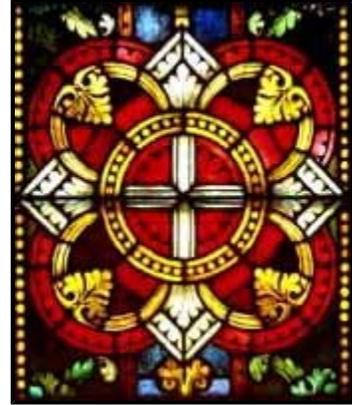
"Stained glass" can mean colored, painted or enameled glass, or glass tinted with true glass "stains." In this Brief the term refers to both colored and painted glass. "Leaded glass" refers generically to all glass assemblies held in place by lead, copper, or zinc comes. Because the construction, protection, and repair techniques of leaded glass units are similar, whether the glass itself is colored or clear, "stained glass" and "leaded glass" are used interchangeably throughout the text.

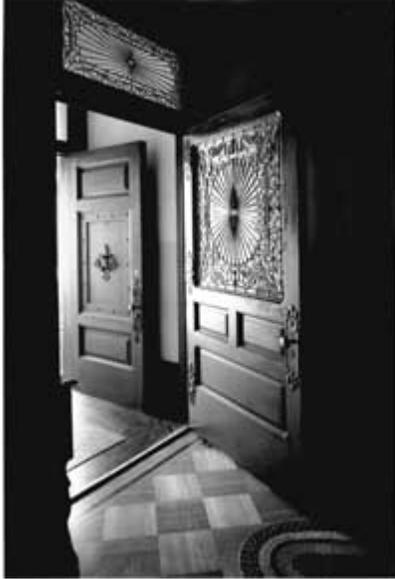
The door and transom of the Edward Hazlett House in Wheeling, West Virginia, (1891-92) suggest the richness of 19th century leaded glass. Photo: Jack E. Boucher, HABS.

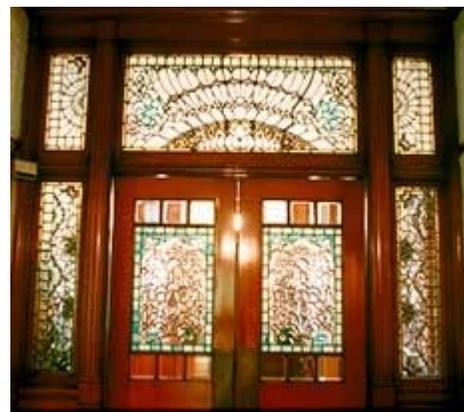
These interior foyer doors deliver dazzling daylight deeper into an 1880s house originally illuminated by gaslight. Photo: Neal A. Vogel.

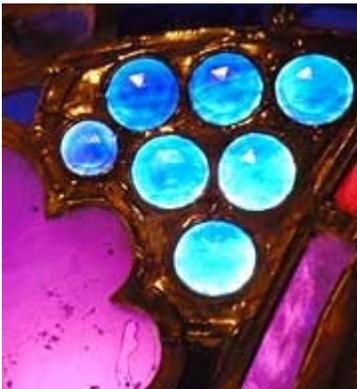
The faceted jewels set in a lead overlay from 1920 were made possible by one of the many glass innovations of the Tiffany Glass & Decorating Company several decades earlier. Photo: Neal A. Vogel.

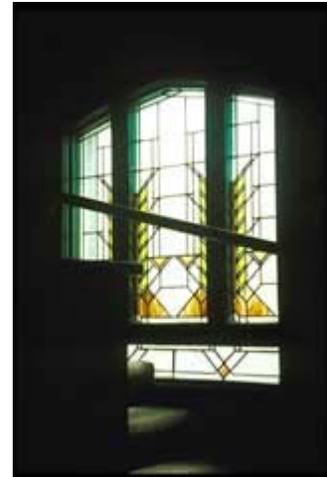
A typical ca. 1910 Prairie School art glass window in Riverside, Illinois, directly influenced by the work of Frank Lloyd Wright. Photo: Neal A. Vogel.

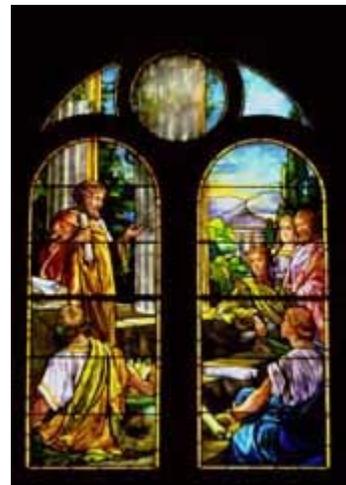
A typical Tiffany-style window includes opalescent glass, intricate leading, copper foil, extensive etching, plating, and a scene with perspective that simulates a painting. Photo: Neal A. Vogel.

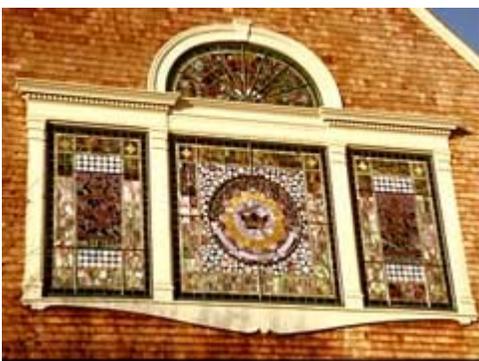
Stained glass is an exterior feature as well as an interior one. As part of any preservation project, it should be photographed from the outside as well as the inside. Photo: Neal A. Vogel.

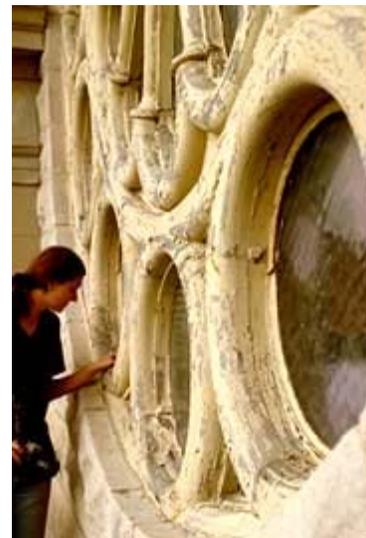
A condition assessment of the frame supporting the stained glass window is as important as evaluating the stained glass itself. Photo: Neal A. Vogel.

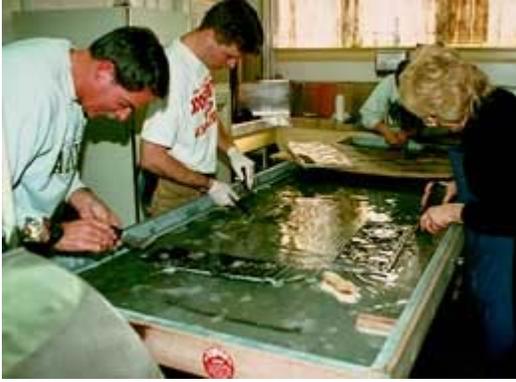
Disassembling leaded glass in warm water helps to soften the putty, minimize breakage, and reduce exposure to airborne dust. Photo: Neal A. Vogel.

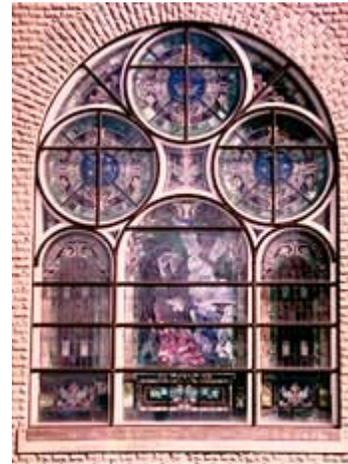
The grid for this protective glazing disregards the configuration of the historic window. The new framing system also causes distracting shadows on the interior. Photo: Neal A. Vogel.

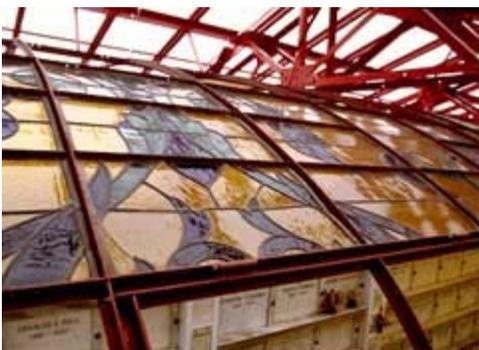
Before repairs began on the vaulted glass ceiling, a new diffusing skylight was installed to correct
