Conserving Energy in Historic Buildings

Baird M. Smith, AIA

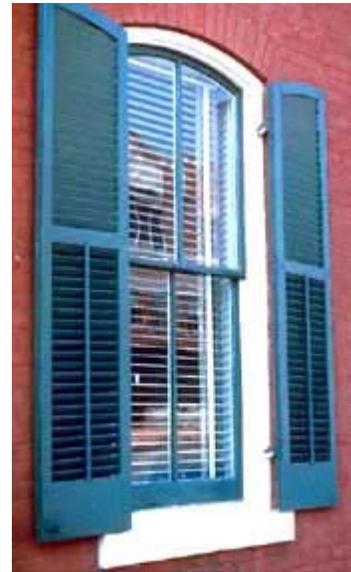
Shutters can be used to minimize the problem of summer heat gain by shading the windows. Photo: NPS files.

Secondly, to minimize the heat gain or loss from windows, historic buildings often include interior or exterior shutters, interior venetian blinds, curtains and drapes, or exterior awnings. Thus, a historic window could remain an energy efficient component of a building.

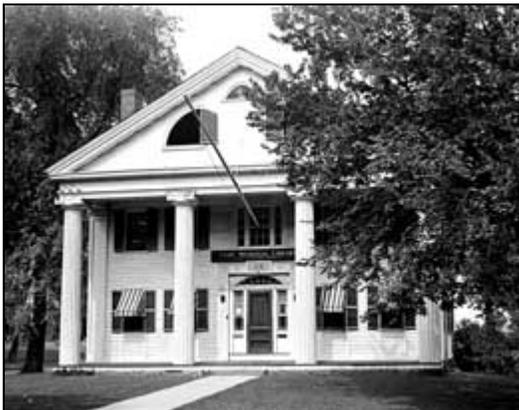
This 19th c. building in Massachusetts employed several energy-conserving features in its historic design, including shade trees, roof overhangs, awnings and shutters. Photo: HABS collection, NPS.

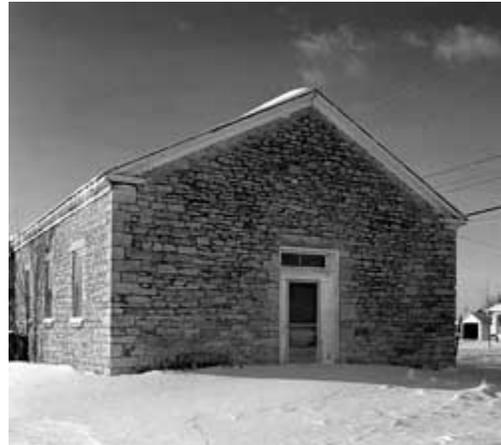
Heavy masonry walls and few windows serve to maximize warmth inside. Photo: HABS collection, NPS.

Winter heat loss from buildings in the northern climates was reduced by using heavy masonry walls, minimizing the number and size of windows, and often using dark paint colors for the exterior walls. The heavy masonry walls used so typically in the late 19th century and early 20th century, exhibit characteristics that improve their thermal performance beyond that formerly recognized. It has been determined that walls of large mass and weight (thick brick or stone) have the advantage of high thermal inertia, also known as the "M factor." This inertia modifies the thermal resistance (R factor) (1) of the wall by lengthening the time scale of heat transmission. For instance, a wall with high thermal inertia, subjected to solar radiation for an hour, will absorb the heat at its outside surface, but transfer it to the interior over a period as long as 6 hours. Conversely, a wall having the same R factor, but low thermal inertia, will transfer the heat in perhaps 2 hours.

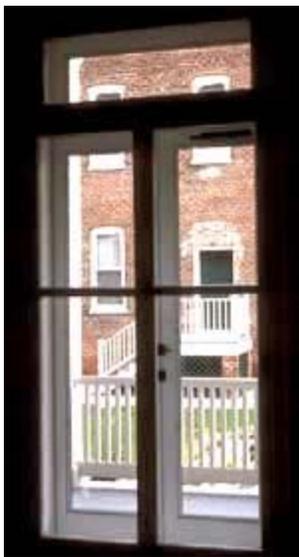
Storm doors have been added on the inside of this historic building as an energy-conserving device. Photo: NPS files.

A storm door would improve the thermal performance of the historic door; however, recent studies indicate that installing a storm door is not normally cost effective in residential settings. The costs are high compared to the anticipated savings. Therefore, storm doors should only be added to buildings in cold climates, and added in such a way to minimize the visual impact on the building's appearance. The storm door design should be compatible with the architectural character of the building and may be painted to match the colors of the historic door.

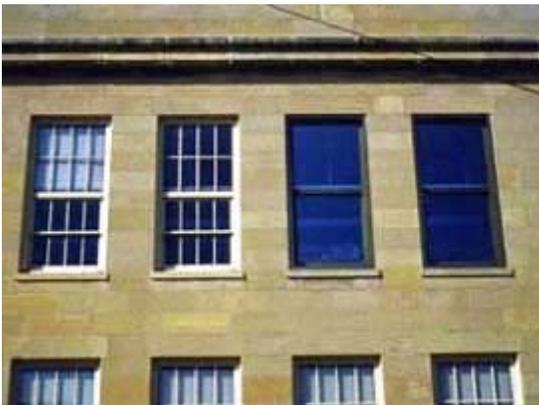
Tinted glazing has jeopardized the character of this historic office building and is, thus, not a recommended approach. Photo: Mike Jackson.

Replacement Windows: Unfortunately, a common weatherization measure, especially in larger buildings, has been the replacement of historic windows with modern double paned windows. The intention was to improve the thermal performance of the existing windows and to reduce longterm maintenance costs. The evidence is clear that adding exterior storm windows is a viable alternative to replacing the historic windows and it is the recommended approach in preservation retrofitting. However, if the historic windows are severely deteriorated and their repair would be impractical, or economically infeasible, then replacement windows may be warranted. The new windows, of either wood or metal, should closely match the historic windows in size, number of panes, muntin shape, frame, color and reflective qualities of the glass.

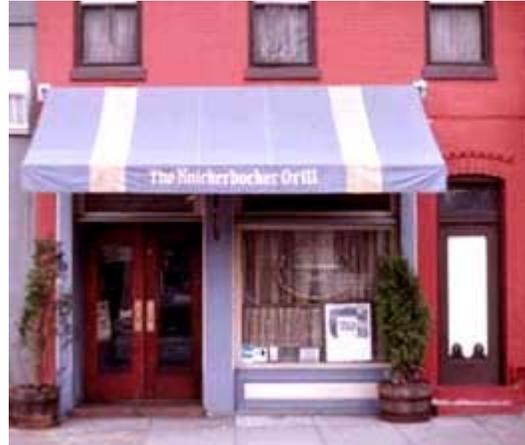
Awnings reduce heat gain in the summer and, when they are raised in the winter, radiant heat from the sun provides free supplementary heat. Photo: NPS files.

Awnings and Shading Devices: In the past, awnings and trees were used extensively to provide shade to keep buildings cooler in the summer. If awnings or trees are in place, keep them in good condition, and take advantage of their energy-saving contribution. Building owners may consider adding awnings or trees if the summer cooling load is substantial. If awnings are added, assure that they are installed without damaging the building or visually impairing its architectural character. If trees are added, select deciduous trees that provide shade in the summer but, after dropping their leaves, would allow the sun to warm the building in the winter. When planting trees, assure that they are no closer than 10 feet to the building to avoid damage to the foundations. Adding either awnings or shade trees may be expensive, but in hot climates, the benefits can justify the costs.
