The Repair of Historic Wooden Windows

John H. Myers

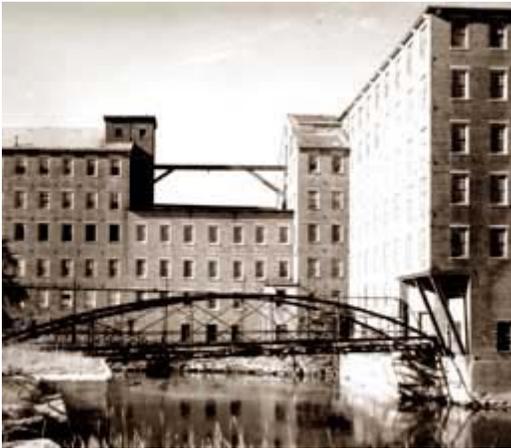
Windows are frequently important visual focal points, especially on simple facades such as this mill building. Replacement of the multi-pane windows with larger panes could dramatically alter the appearance of the building. Photo: NPS files.

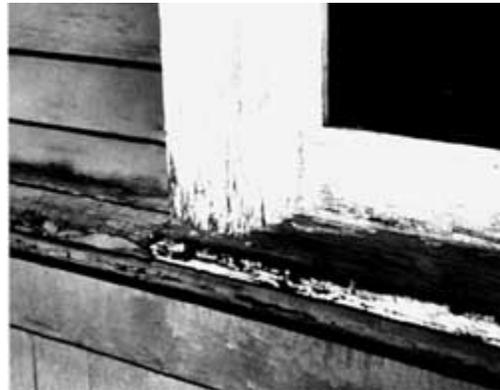
Deterioration of poorly maintained windows usually begins on horizontal surfaces and at joints, where water can collect and saturate the wood. Photo: NPS files.

Each window should be examined for operational soundness beginning with the lower portions of the frame and sash. Exterior rainwater and interior condensation can flow downward along the window, entering and collecting at points where the flow is blocked. The sill, joints between the sill and jamb, corners of the bottom rails and muntin joints are typical points where water collects and deterioration begins. The operation of the window (continuous opening and closing over the years and seasonal temperature changes) weakens the joints, causing movement and slight separation. This process makes the joints more vulnerable to water which is readily absorbed into the endgrain of the wood. If severe deterioration exists in these areas, it will usually be apparent on visual inspection, but other less severely deteriorated areas of the wood may be tested by two traditional methods using a small ice pick.

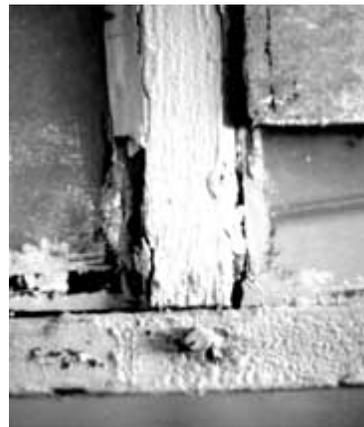
This historic double-hung window has many layers of paint, some cracked and missing putty, slight separation at the joints, broken sash cords, and one cracked pane. Photo: NPS files.

The routine maintenance required to upgrade a window to "like new" condition normally includes the following steps: 1) some degree of interior and exterior paint removal, 2) removal and repair of sash (including reglazing where necessary), 3) repairs to the frame, 4) weatherstripping and reinstallation of the sash, and 5) repainting. These operations are illustrated for a typical double-hung wooden window, but they may be adapted to other window types and styles as applicable.

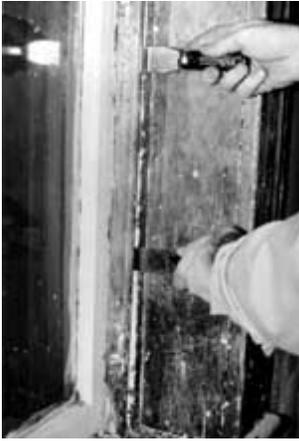
After removing paint from the seam between the interior stop and the jamb, the stop can be pried out and gradually worked loose using a pair of putty knives as shown. Photo: NPS files.

Paint removal should begin on the interior frames, being careful to remove the paint from the interior stop and the parting bead, particularly along the seam where these stops meet the jamb.

This can be accomplished by running a utility knife along the length of the seam, breaking the paint bond. It will then be much easier to remove the stop, the parting bead and the sash. The interior stop may be initially loosened from the sash side to avoid visible scarring of the wood and then gradually pried loose using a pair of putty knives, working up and down the stop in small increments. With the stop removed, the lower or interior sash may be withdrawn. The sash cords should be detached from the sides of the sash and their ends may be pinned with a nail or tied in a knot to prevent them from falling into the weight pocket.

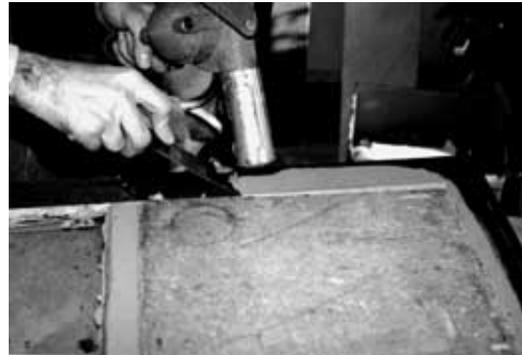
Sash can be removed and repaired in a convenient work area. Paint is being removed from this sash with a hot air gun. Photo: NPS files.

The sash can be stripped of paint using appropriate techniques, but if any heat treatment is used, the glass should be removed or protected from the sudden temperature change which can cause breakage. An overlay of aluminum foil on gypsum board or asbestos can protect the glass from such rapid temperature change. It is important to protect the glass because it may be historic and often adds character to the window. Deteriorated putty should be removed manually, taking care not to the wood along the rabbet. If the glass is to be removed, the glazing points which hold the glass in place can be extracted and the panes numbered and removed for cleaning and reuse in the same openings. With the glass panes out, the remaining putty can be removed and the sash can be sanded, patched, and primed with a preservative primer. Hardened putty in the rabbets may be softened by heating with a soldering iron at the point of removal. Putty remaining on the glass may be softened by soaking the panes in linseed oil, and then removed with less risk of breaking the glass. Before reinstalling the glass, a bead of glazing compound or linseed oil putty should be laid around the rabbet

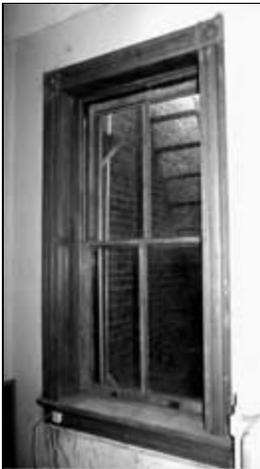
Following the relatively simple repairs, the window is weathertight, like new in appearance, and serviceable for many years to come. Photo: NPS files.

The operations just discussed summarize the efforts necessary to restore a window with minor deterioration to "like new" condition. The techniques can be applied by an unskilled person with minimal training and experience. To demonstrate the practicality of this approach, and photograph it, a Technical Preservation Services staff member repaired a wooden double-hung, two over two window which had been in service over ninety years. The wood was structurally sound but the window had one broken pane, many layers of paint, broken sash cords and inadequate, worn-out weatherstripping. The staff member found that the frame could be stripped of paint and the sash removed quite easily. Paint, putty and glass removal required about one hour for each sash, and the reglazing of both sash was accomplished in about one hour. Weatherstripping of the sash and frame, replacement of the sash cords and reinstallation of the sash, parting bead, and stop required an hour and a half. These times refer only to individual operations; the entire process took several days due to the drying and curing times for putty, primer, and paint, however, work on other window units could have been in

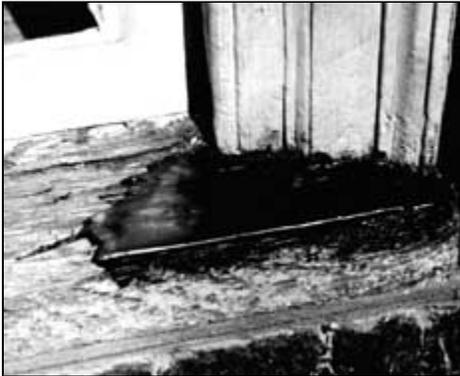
This illustrates a two-part epoxy patching compound used to fill the surface of a weathered sill and rebuild the missing edge. When the epoxy cures, it can be sanded smooth and painted to achieve a durable and waterproof repair. Photo: NPS files.

Wood may also be strengthened and stabilized by consolidation, using semirigid epoxies which saturate the porous decayed wood and then harden. The surface of the consolidated wood can then be filled with a semirigid epoxy patching compound, sanded and painted. Epoxy patching compounds can be used to build up missing

sections or decayed ends of members. Profiles can be duplicated using hand molds, which are created by pressing a ball of patching compound over a sound section of the profile which has been rubbed with butcher's wax. This can be a very efficient technique where there are many typical repairs to be done. The process has been widely used and proven in marine applications; and proprietary products are available at hardware and marine supply stores. Although epoxy materials may be comparatively expensive, they hold the promise of being among the most durable and long lasting materials available for wood repair. More information on epoxies can be found in the publication "Epoxies for Wood Repairs in Historic Buildings," cited in the bibliography.
